CERAMIC ROTOR BLADE DEVELOPMENT

PART I - CERAMIC THERMAL BARRIER COATINGS

Fourth Semi-Annual Technical Report
Research Project 421-1
Contract Manager: Dr. Art Cohn

Westinghouse R&D Center
1310 Beulah Road
Pittsburgh, Pennsylvania 15235

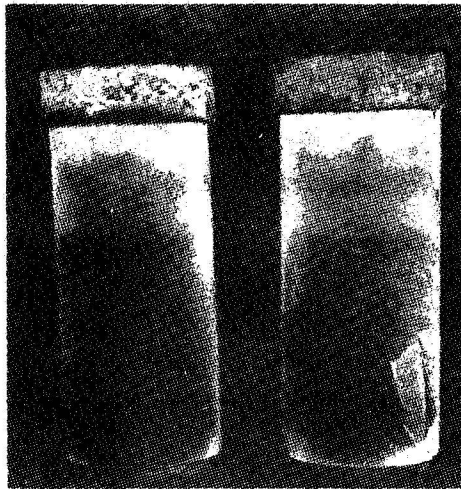
(a) 37 hr exposure

(b) 63.5 hr exposure

Coated U-500 air-cooled specimens after exposure in pressurized turbine test passage under following conditions:

Gas Temperature : 2000°F

Gas velocity : 500 fps

Max. Metal Temp. : 1650°F

Avg. Metal Temp. : 1450°F

Pressure : 3 atm.

Fuel : GT-2 diesel + 5 ppm Na

+ 2 ppm V + 0.5 wt% S.

Fig. 18 - The NASA- and Linde-coated specimens after exposure for different periods at 1650°F maximum metal temperature.

After 37 hours of exposure, the oxide coating on the NASA-coated specimen was found intact while that on the Linde-coated specimen experienced some spalling as shown in Fig. 18. However, with further exposure to a total of 63.5 hrs, the NASA coating also showed oxide spalling while the amount of oxide spalling increased on the Linde-coated specimen. The severe spalling on the Linde-coated specimen is illustrated in Fig. 19 by four views of the specimen after 63.5 hrs of exposure. The metallographic cross-sections from four different locations around the circumference of this exposed specimen are shown in Fig. 20. These reveal that numerous cracks develop in the oxide coating during exposure to the hot combustion gases which, in turn, cause spalling of the oxide coating. Again, no corrosion of the bond coat is apparent in these micrographs.

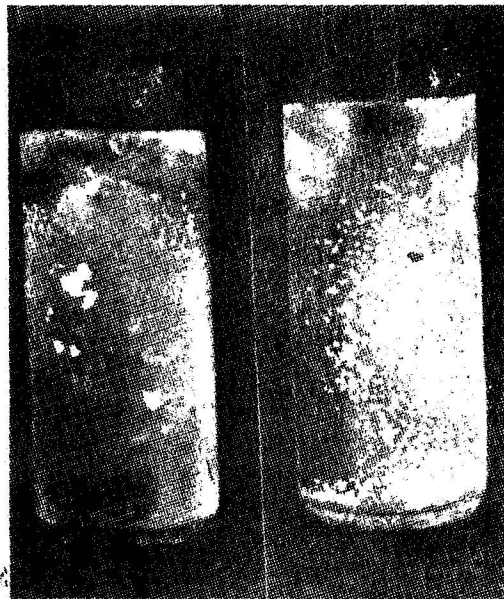
Fig. 21 - The NASA-coated specimen after 100 hours of exposure
at 1650°F maximum metal temperature.

As shown in Fig. 21, similar severe spalling of the oxide coating on the NASA coated specimen has been found to occur with further exposure to a total of 100 hrs.
